# **Clean-in-Place and Reliability Testing of a Commercial 12.5-cm Annular Centrifugal Contactor at the INL**

**Global 2007**

**September 2007**

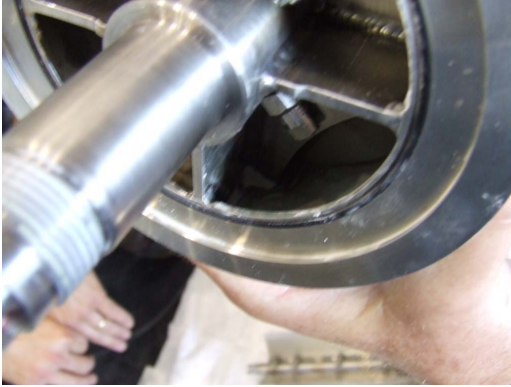
Fig. 5. Solids capture, upper weir.

Figures 4 through 7 pictorially display the presence and location of solids accumulation within the contactor assembly following loading of 109 L of a 0.1 wt % diatomaceous earth solution. Figure 4 displays a thick cake of diatomaceous earth within the rotor. It should be noted that an evenly distributed cake was most likely present during operation, but during rotor holdup draining, the solids sloughed to the bottom of the rotor assembly. Figure 5 displays solids present in the upper weir assembly. Though difficult to see, minimal solids were present in the upper weir package indicating a sufficient cake had formed allowing solids to pass over the upper weir and exiting the contactor with the effluent. When referring to figure 6, solids can be observed in the bottom of the vane package (top center of photo). Figure 7 displays solids present in the bottom mixing plate.

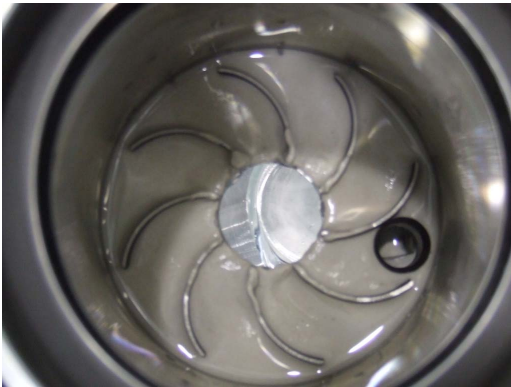
Fig. 7. Solids capture, mixing plate.

CIP processes performed at 40 psig (25.4 lpm) for three 15 or three 10 second cycles were very effective at the removal of solids from internal contactor surfaces. In addition, previous experience has shown some solids holdup within the torturous path of the bottom housing mixing plate. Additional drains could be added to alleviate this potential problem and should be considered in future modifications.

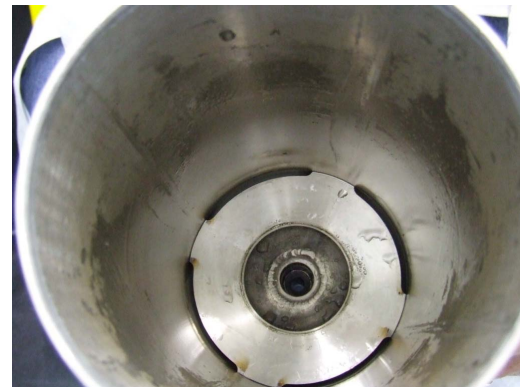
Fig. 8. Following CIP, inside rotor.

Figures 8 through 11 pictorially summarize the complete removal of solids within the contactor assembly following the ten second CIP clean out test. Figures 8 and 10 display the absence of solids within the rotor and vane packages. In addition, no solids were present in the upper weir or bottom mixing plate as shown in figures 9 and 11. Pictures of contactor parts following the second CIP process performed for 15 seconds are not shown. However, comparable results were obtained.
